The
San Francisco Earthquake and Fire

A BRIEF HISTORY OF THE DISASTER

A Presentation of Facts and Resulting Phenomena, with Special
Reference to the Efficiency of Building Materials
Lessons of the Disaster

A. L. A. HIMMELWRIGHT, C.E.

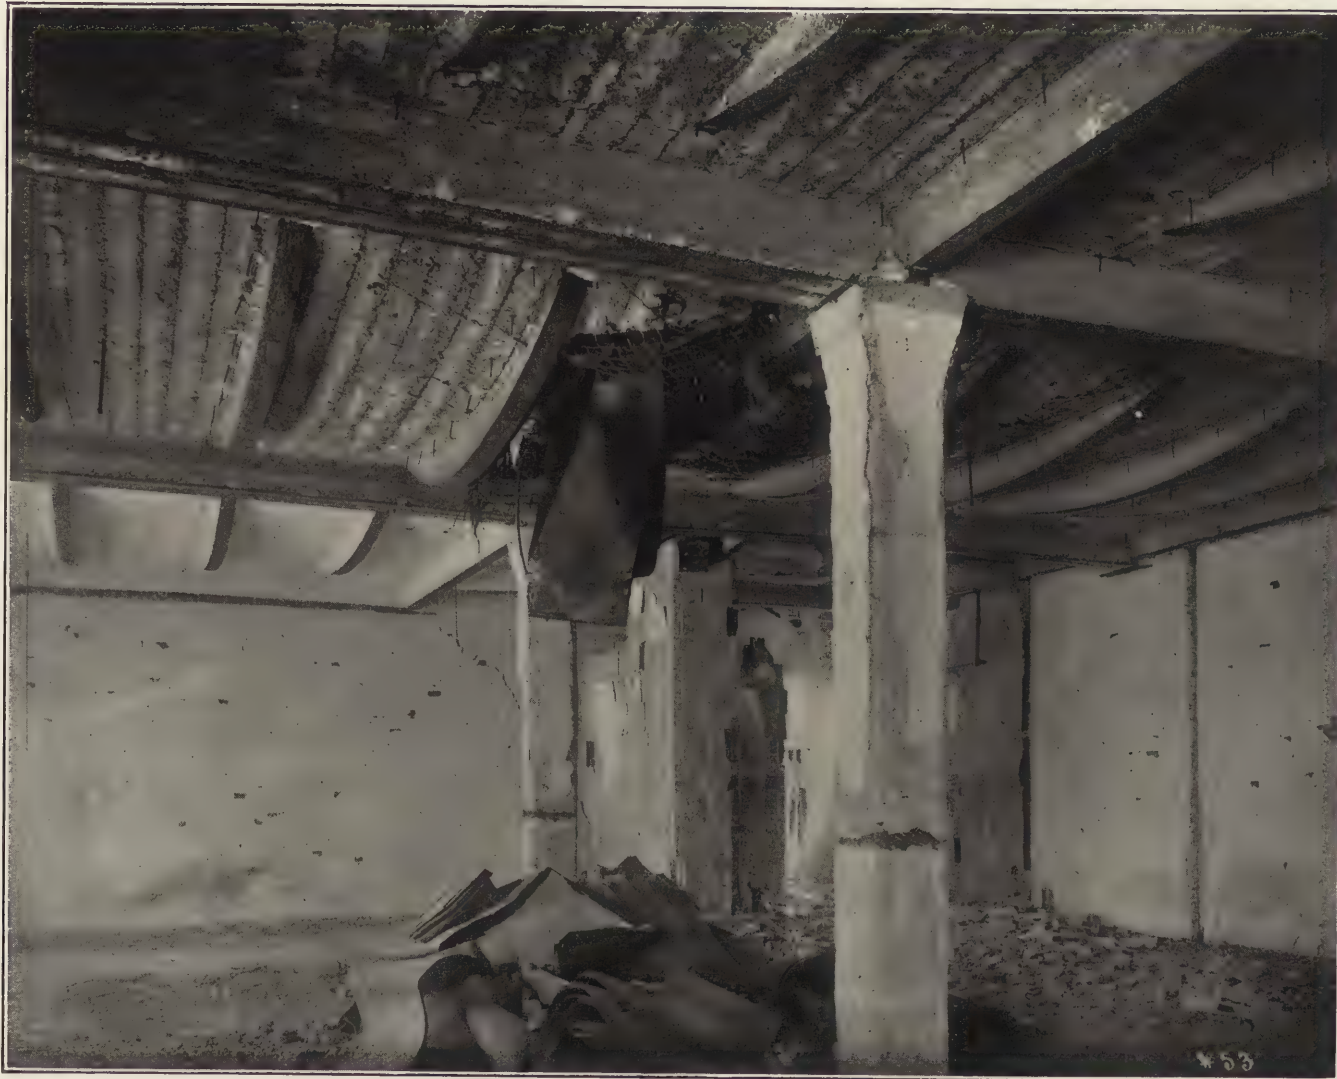
YOUNG BUILDING. Second Story. Showing the condition of the under side of the suspender system of the expanded metal floors. One floor span is broken down by sheet iron which fell through from the fourth story. This floor construction, on account of the expansion of the exposed suspender band, deflected badly throughout the building, even where there was little or no load resting on it. There is an earthquake crack in the rear wall in the centre. The hollow tile partition around the toilet-room in the rear is badly wrecked. The crack around the expanded metal lath and plaster column covering, about five feet from the floor, occurs throughout the building, and probably marks the height of the wood trim, or the sections of the completed plaster work during the construction of the building.

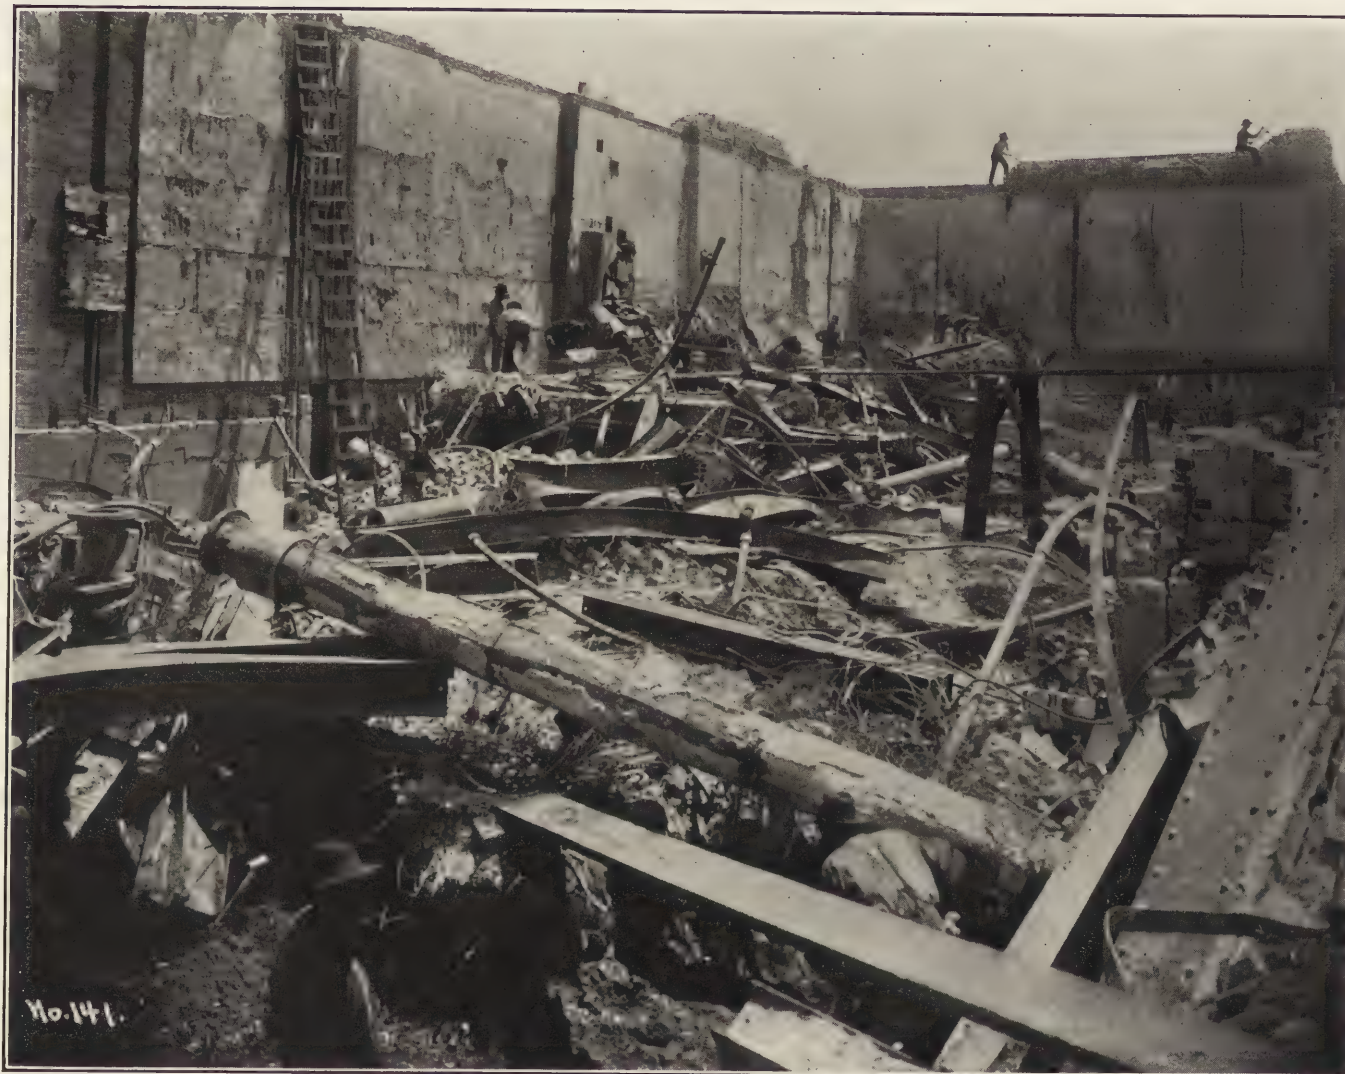
BUCKLEY BUILDING. This was a Class B building with metal frame and wood floors, excepting a small section in the rear corner of the building, which contained Roebling concrete floors. The brick walls, steel framing, and other *débris*, from the upper parts of the building, fell on this section of flooring, and elsewhere in the basement, to a depth of five feet. At the time the photograph was taken, workmen had cleared away a large portion of the *débris* resting on the concrete floor, which can now be clearly seen in the illustration. Note the wire lath and plaster wall furring adhering to the remaining walls.

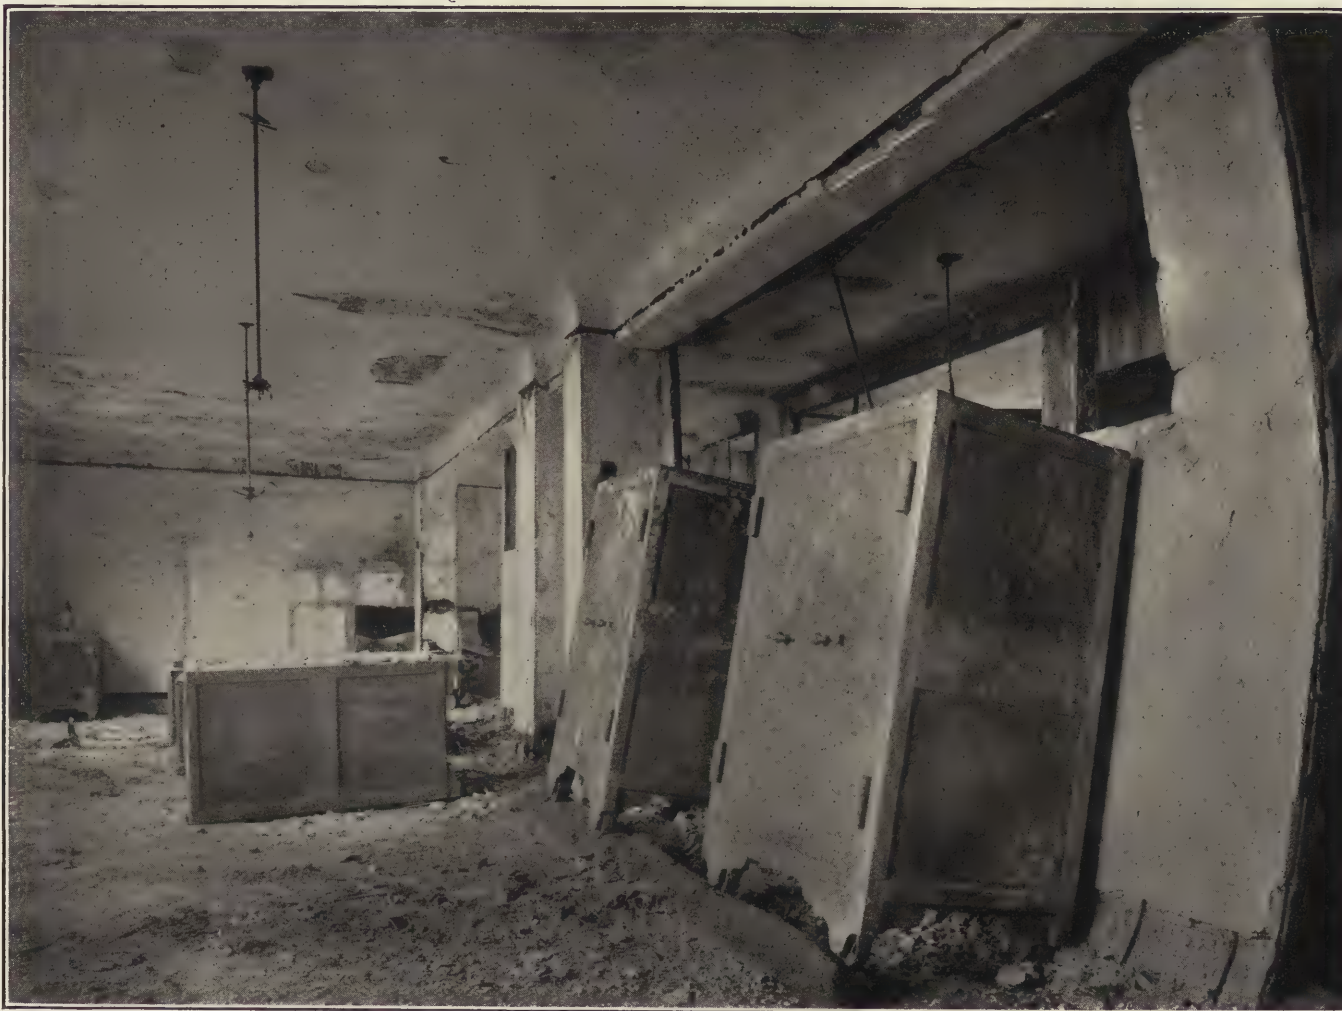
MUTUAL SAVINGS BANK. Fourth Story. Showing five large safes and one small one in one of the offices on the Market Street side. The safes were mounted on 8" x 8" timbers. The latter burnt out wholly or in part, causing the two safes in the foreground to tilt against the Roebling 2" wire lath and plaster partition, which remains standing though badly bulged out of line. The three large safes in the rear were overthrown when the timbers burned. The Roebling concrete floors withstood the impact of the falling safes and sustained them safely during the fire.

Notwithstanding the fact that there were a large number of heavy safes scattered throughout the building, some of which were thrown flat side down on the floors, not a single safe broke through. Some of the safes were mounted on 8" x 8" timbers from which they were shaken by the earthquake. Where the safes remained in position after the earthquake, the fire consumed the skids wholly or in part, which generally caused the safes to drop down on the floor or tilted them over. On the fourth floor, at the Market Street side, one small office contained five large safes and one small one. These were mounted on timbers. Two of these, on account of the sleepers being partly consumed, tilted against the 2" partition back of them, bulging out the partition (which remained standing). Three other safes, 3' x 4' x 6' high, were thrown bodily forward on the floor, but did no damage except that one of them punctured the floor, making a hole about 10" x 20" in size. This is the only damage to the floors that was noted in the entire building. The other small safe in the room referred to remains standing on the floor.

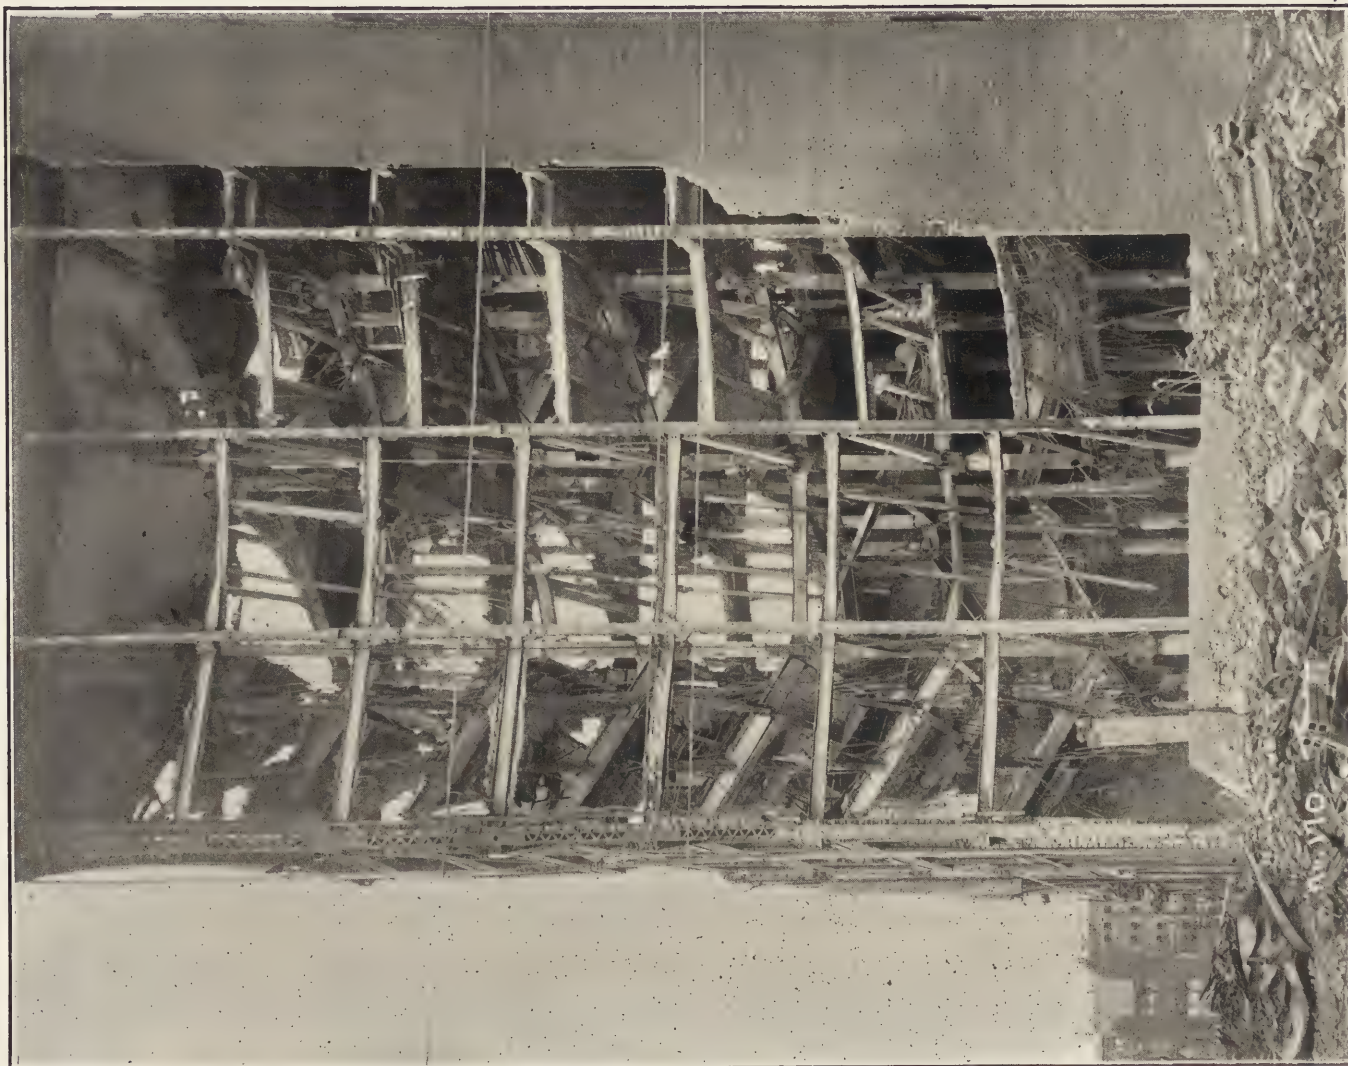
KAMM BUILDING. Showing the collapsed rear portion of the building caused by column failures in the basement. The tenacity of the connections of the wall girders at the columns is remarkable. Two beams framed to them, when carried downward in the centre, have twisted the girders in the middle section through an angle of about 80 degrees from the vertical. The Roebling concrete floors cling to the beams; seven tiers in the rear of the building being inclined at an angle of about 35 degrees, and other sections of the floors being warped and distorted into almost every conceivable shape. Note the curved skyline of the rear where the central columns have been drawn inward by the collapse.

The entire rear portion of the building was wrecked by the failure of seven columns in the basement. A wall-paper concern occupied the lower stories of this building and had a storage room in the basement. The latter was solidly filled with a stock of wall-paper, which made an intensely hot fire of long duration. On May 19th, just a month after the original conflagration, the fire was still burning in a blaze in the basement, which story could not be touched by workmen who were clearing up *débris* in other parts of the building.

The south half of the east and west walls and the entire rear wall are down, but the distorted steel frame is still standing. The settling of the interior columns in the rear portion has broken many of the connections of the beams and girders away from them, so that the latter hang to the wall columns, with sections of the concrete floor still adhering to them in many cases. The front half of the building is in good condition. The metal frame is uninjured. The concrete floors are in first-class condition. The partitions remain standing, but a small percentage are buckled out of plumb. The stairway and elevator fronts are greatly damaged. The seventh story was divided into small offices. A tank on the roof in the rear dropped to the seventh floor, carrying part of the roof framing with it when that portion of the building collapsed.

The entire rear portion of the building will require reconstruction. The forward portion can be repaired and occupied while the rear portion is being rebuilt.

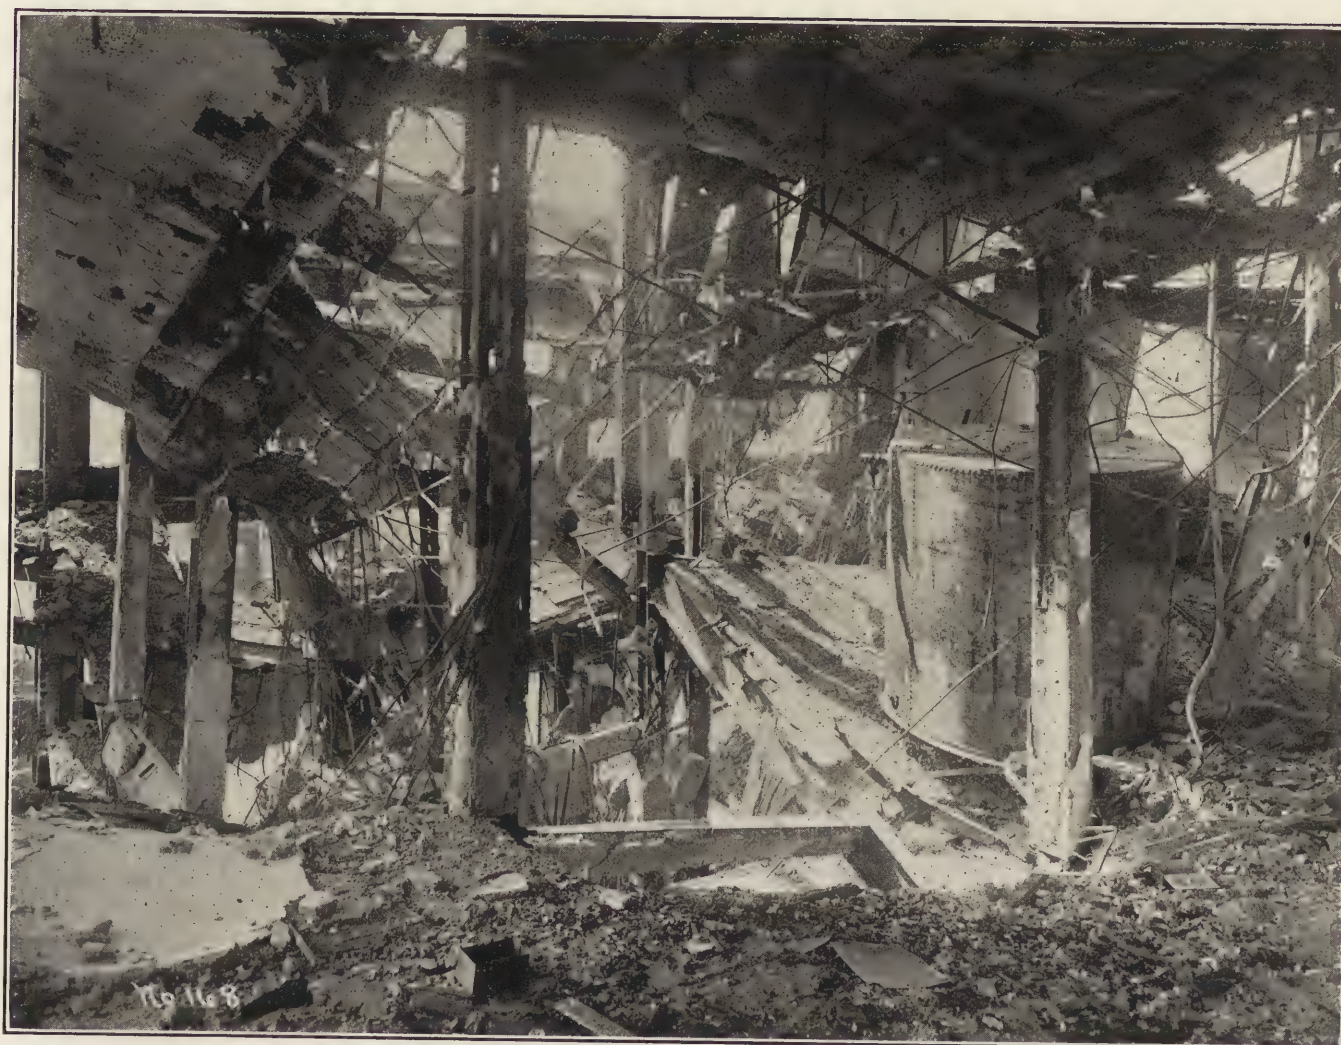
KAMM BUILDING. Seventh Story. Showing the rear collapsed portion of the building at this level, looking southeast. The water tank at the right fell from the roof and was held by a section of Roebling concrete flooring that was still supported by the steel work. Note the furring and lathing of the columns which still remains generally in place after the plaster has been jarred and stripped off by wreckage.

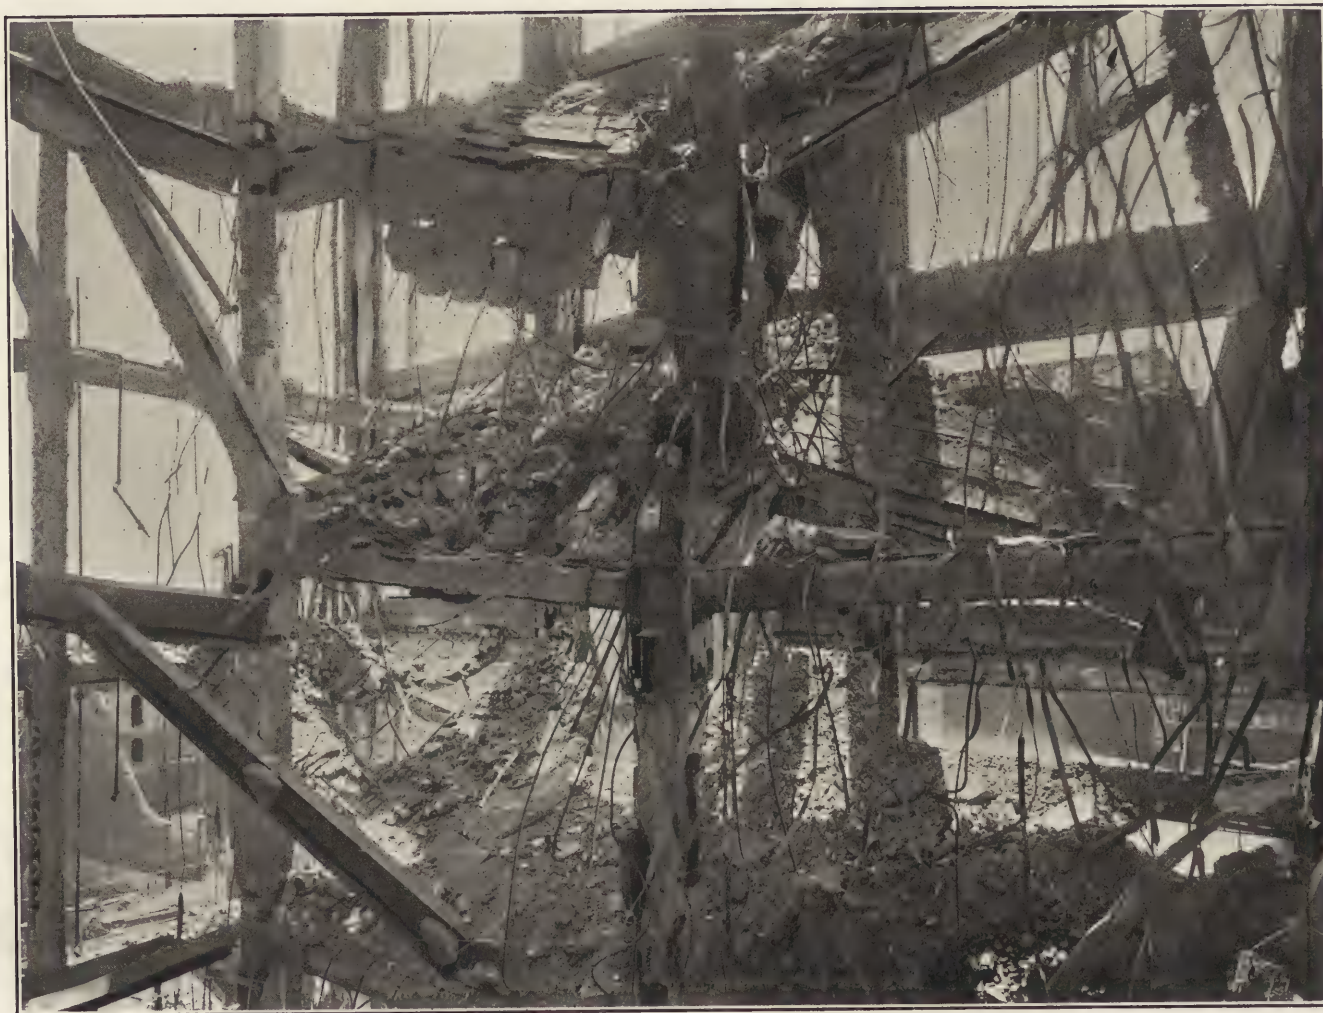
KAMM BUILDING. Fifth Story. From within, looking into the rear portion of the building, which was wrecked by column failures in the basement. The Roebling concrete floor slabs of seven tiers at the rear end of the building are inclined at an angle of about 35 degrees, and remain generally in place. This view was taken to show a badly buckled latticed channel column in the centre foreground which was caused by abnormal strains and loads, and not by heat. Note the tenacity of the crimped wire lath and cement plaster soffit protection, which remains in place after the wreckage has destroyed the floor slabs.

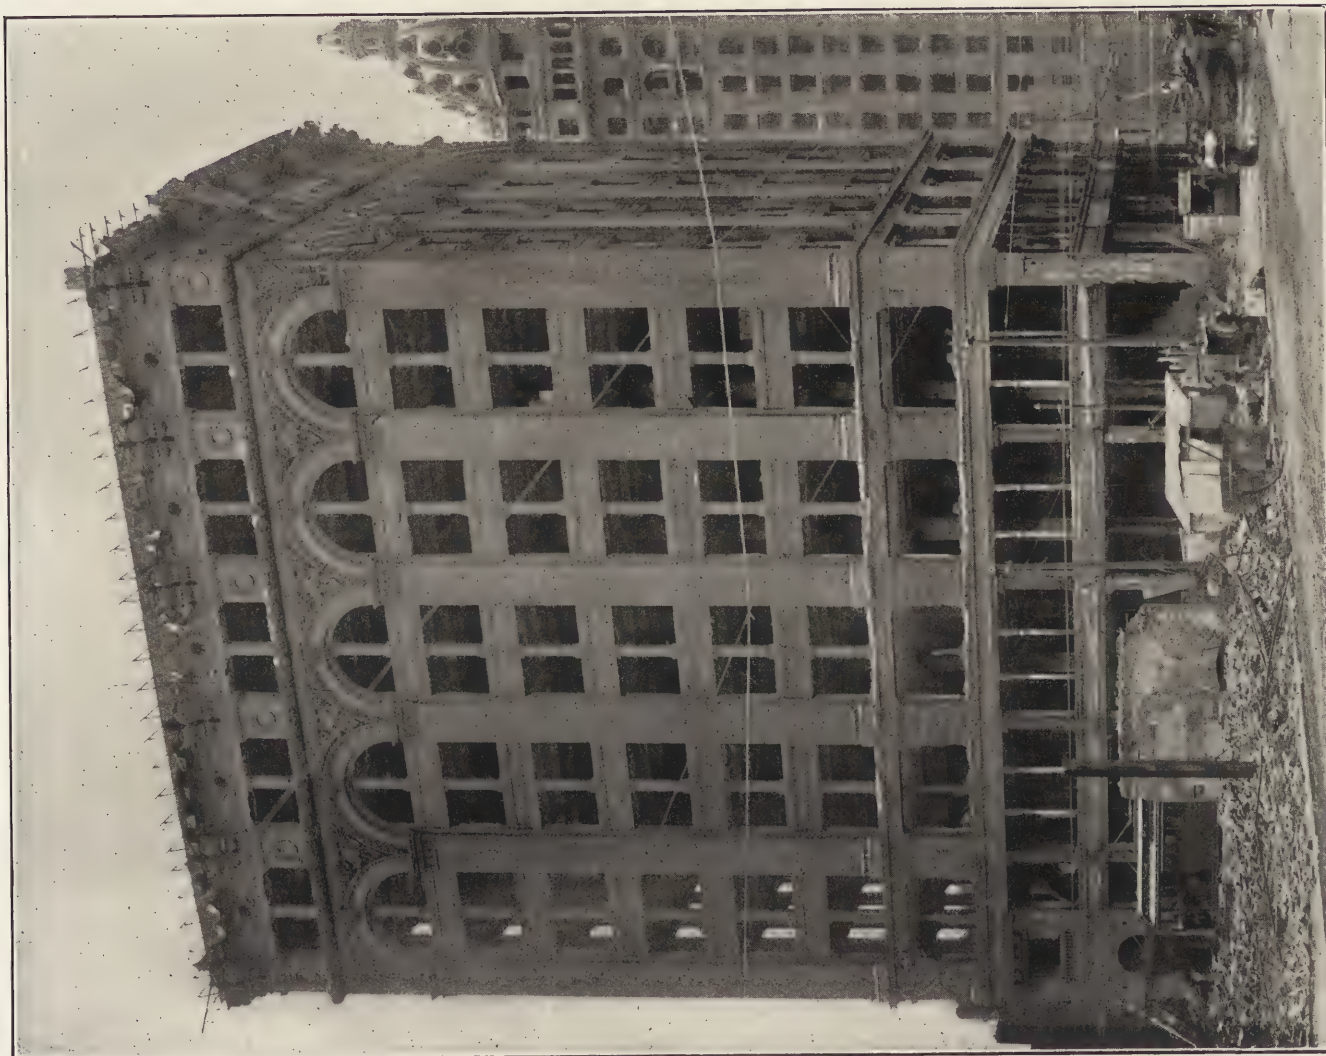
The sand-stone of both fronts is badly spalled by the fire, and on the Third Street side it is considerably cracked by the earth-

ARONSON BUILDING. Northwest Corner Third and Mission Streets. The façades for the three lower stories consist of Colusa sand-stone, which is badly spalled and damaged. The upper stories of buff terra cotta pressed brick, with terra cotta ornaments, are but slightly injured, the terra cotta being spalled and cracked in a few places. The metal cornice is completely wrecked. The rear walls of common brick were considerably racked and damaged by the earthquake. All the walls remain practically plumb. Columns in the basement, first, fifth, eighth and tenth stories have buckled on account of the failure of the hollow tile protection. The Roebling concrete floors, with crimped wire lath and cement plastered soffit protection, remain in first-class condition throughout, notwithstanding the warped condition of the steel work, due to the buckling of the columns. The 4" hollow tile partitions are badly wrecked throughout, about 80 per cent. of the entire work having fallen down. The failure of the hollow tile partitions totally wrecked the cast-iron and marble tread stairways.

quake. The pressed brick and terra cotta above is in good condition. At the third-story level the walls between window openings are badly cracked by the earthquake. The northeast corner at the first story is badly racked. The north and west walls of common brick are in fair condition. All the walls are practically plumb, the greatest variation from the plumb being at the southeast corner, where the south front leans to the north about $\frac{3}{8}$ ". The levels on the water table do not disclose any material displacement of the foundation.

as would naturally result from the combustion of considerable stock, wood finish, furniture, etc., in a building of this character. The sand-stone portions of the front will require renewal. The several columns that have been buckled can be replaced. The elevator fronts, stairways, partitions, column protection and all the plaster work must be completely renewed and rebuilt.

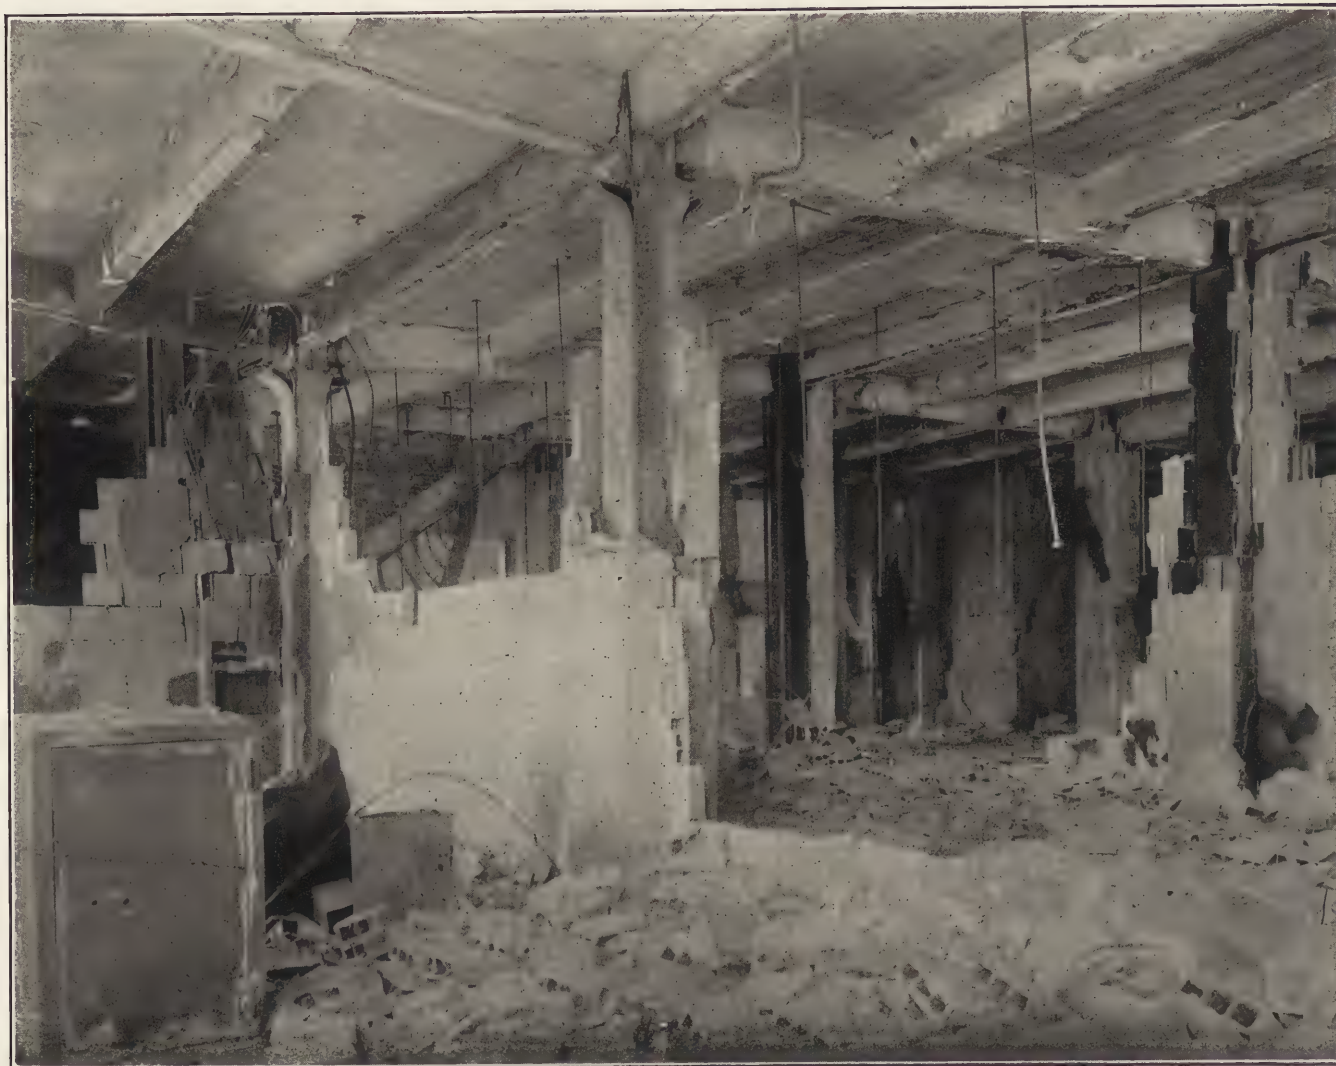
ARONSON BUILDING. First story. Showing the buckling of two columns near the ceiling line, left of the centre. The hollow tile column protection and partitions are badly wrecked in this story. The bulging of the pipes probably caused the failure of the protection of the buckled column on the left. The Roebling stone concrete floors with crimped wire lath and cement plaster soffit protection are uninjured, although the buckling of the columns shown caused the floors above to settle about 18 inches. The falling of the hollow tile partition blocks enclosing the stairway in the rear wrecked it.

One of the columns in the basement on the east side has buckled. In the southwest corner of the first story, two columns have buckled near the ceiling. The failure of one of these was caused by the bulging of pipes within the fire-proof protection. In the northwest corner in the fifth story, one of the columns buckled so that the floors settled about 18". On the eighth floor, in the northwest corner of the building, another column is badly buckled. The same column on the tenth story buckled also. One column deflected slightly in this story.

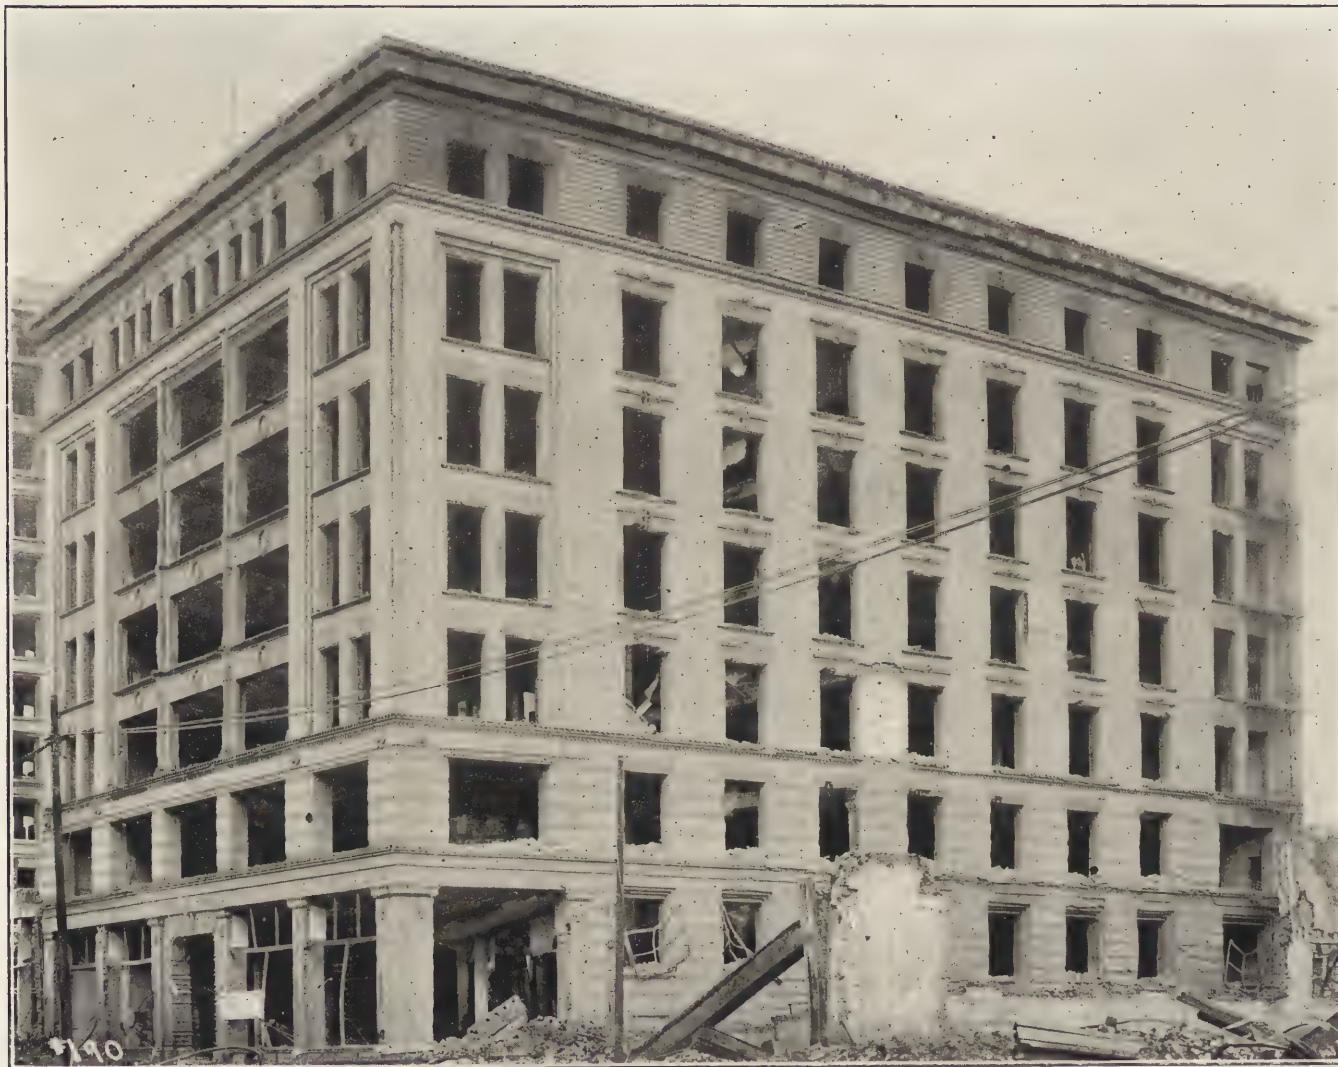
SLOANE BUILDING. North Side of Post Street between Grant Avenue and Stockton Street. The façades consisting of terra cotta for the first story and pressed terra cotta buff brick and terra cotta ornaments above, are in fair condition. The ornamental terra cotta is spalled considerably, but the pressed brick remain in fair condition, except several spots where the bonding has been broken by the earthquake and they have fallen away. Sections of the rear walls, near the top, have fallen down. On account of being left exposed, six interior cast-iron columns in the basement failed from the fire and wrecked a large portion of the interior of the building. The small sum of \$300.00 devoted to the suitable protection of these columns would no doubt have saved \$50,000.00 in the cost of the repairs to this building.

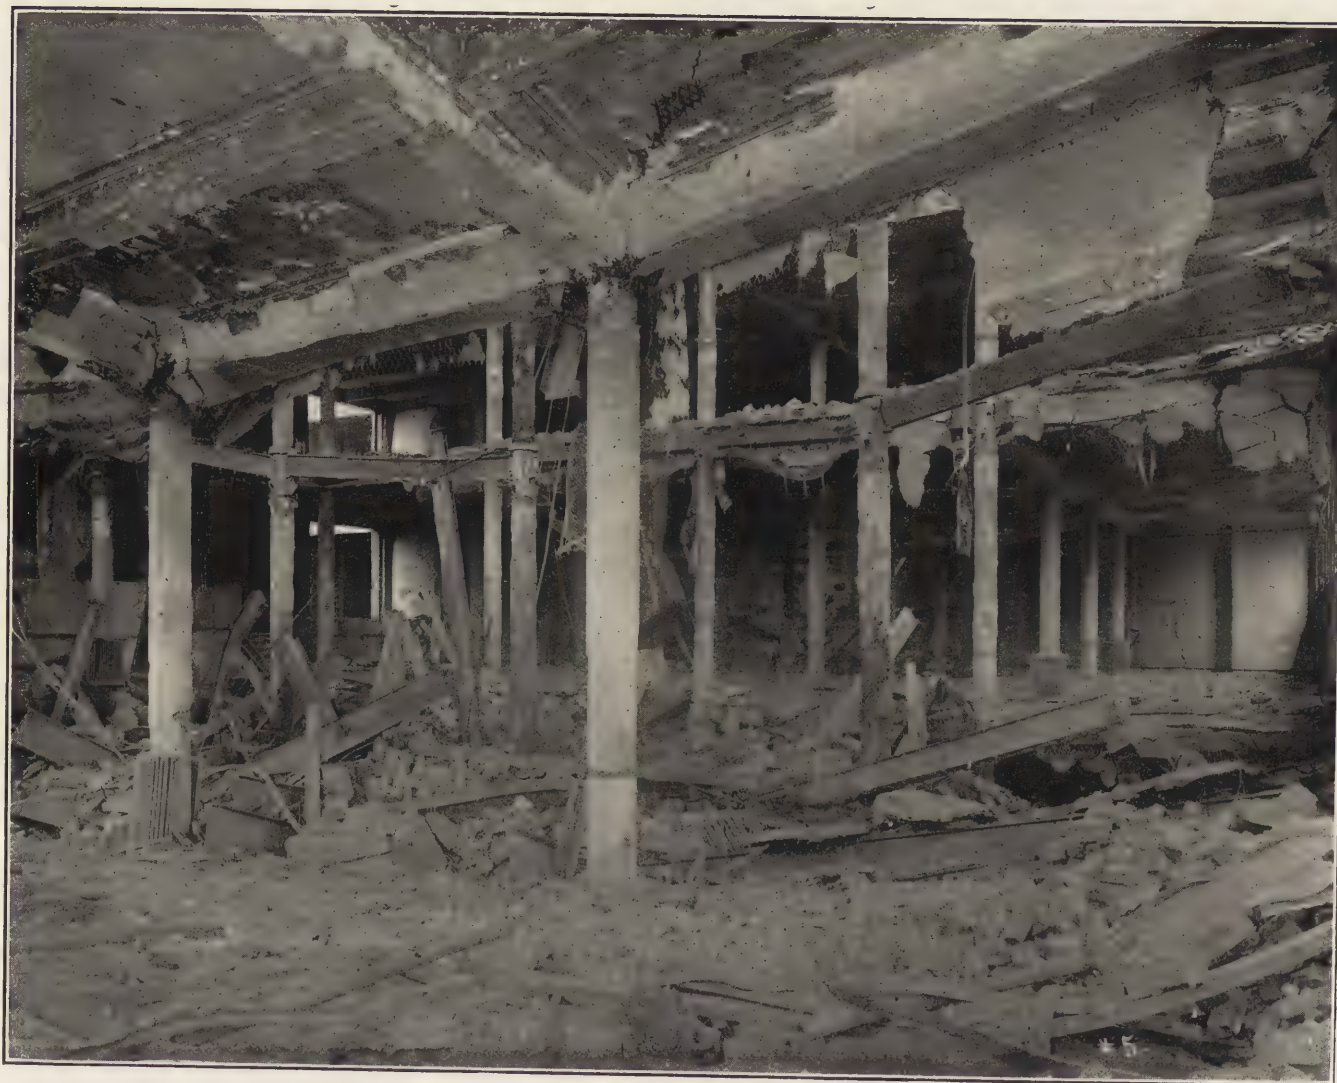
SLOANE BUILDING. First Story. Showing damage caused by the failure of unprotected columns in the basement. Note the concrete clinging to the distorted steel work and hanging down in sheets where the supports have been removed from one side.

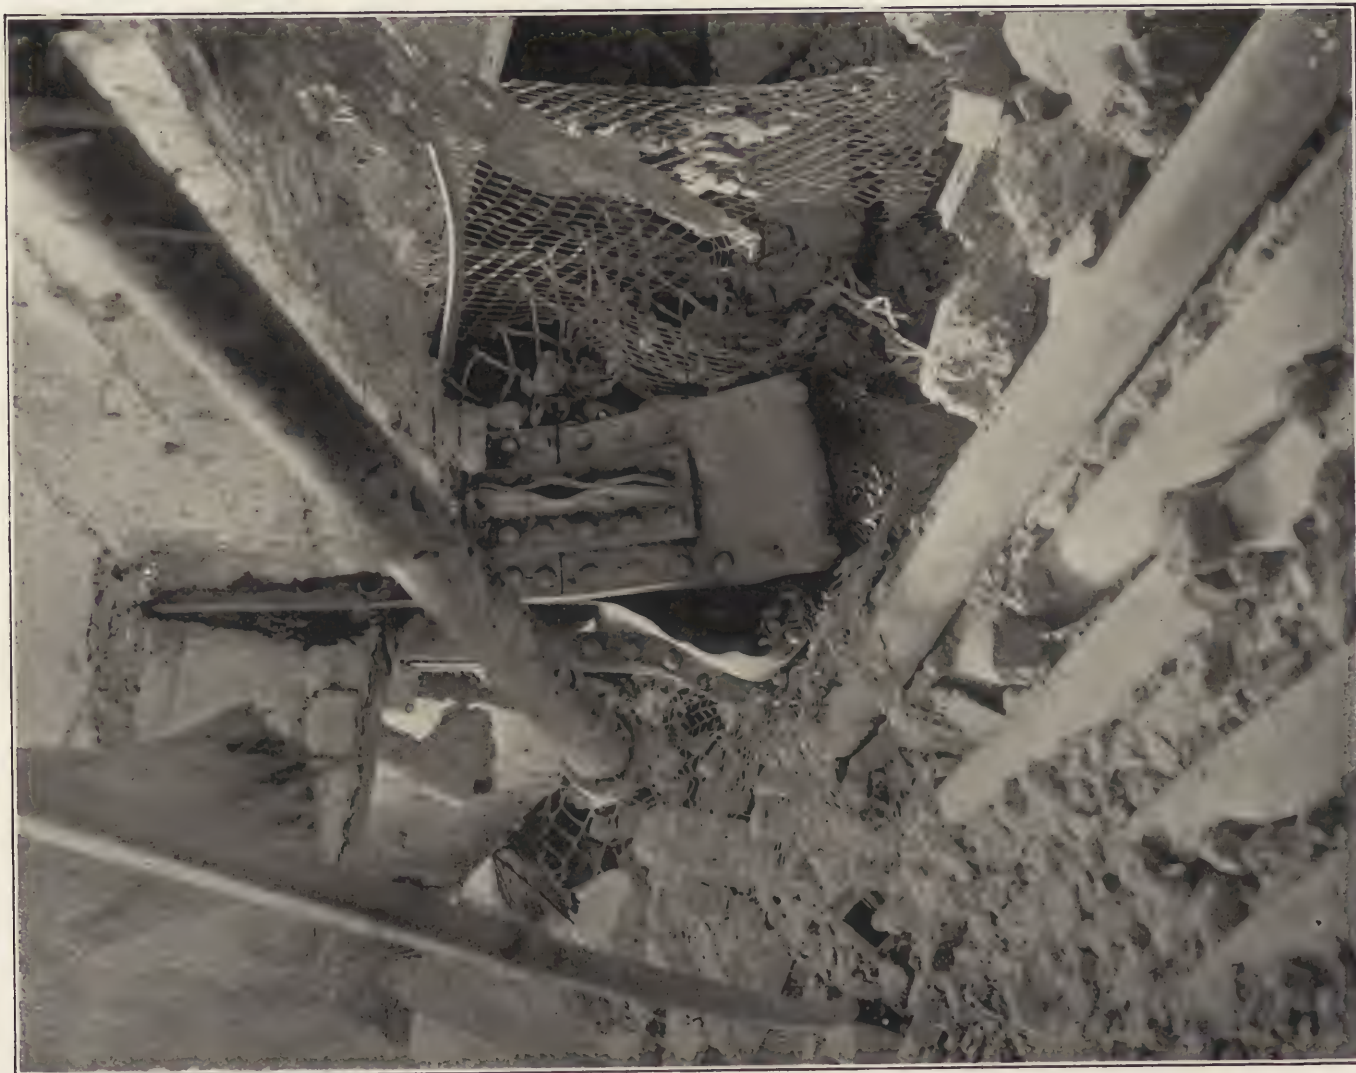
RIALTO BUILDING. Basement Story. Showing a bad column failure under the wrecked portion of the building on the New Montgomery Street side. The concrete floors remain in place, notwithstanding the great distortion of the steel work.

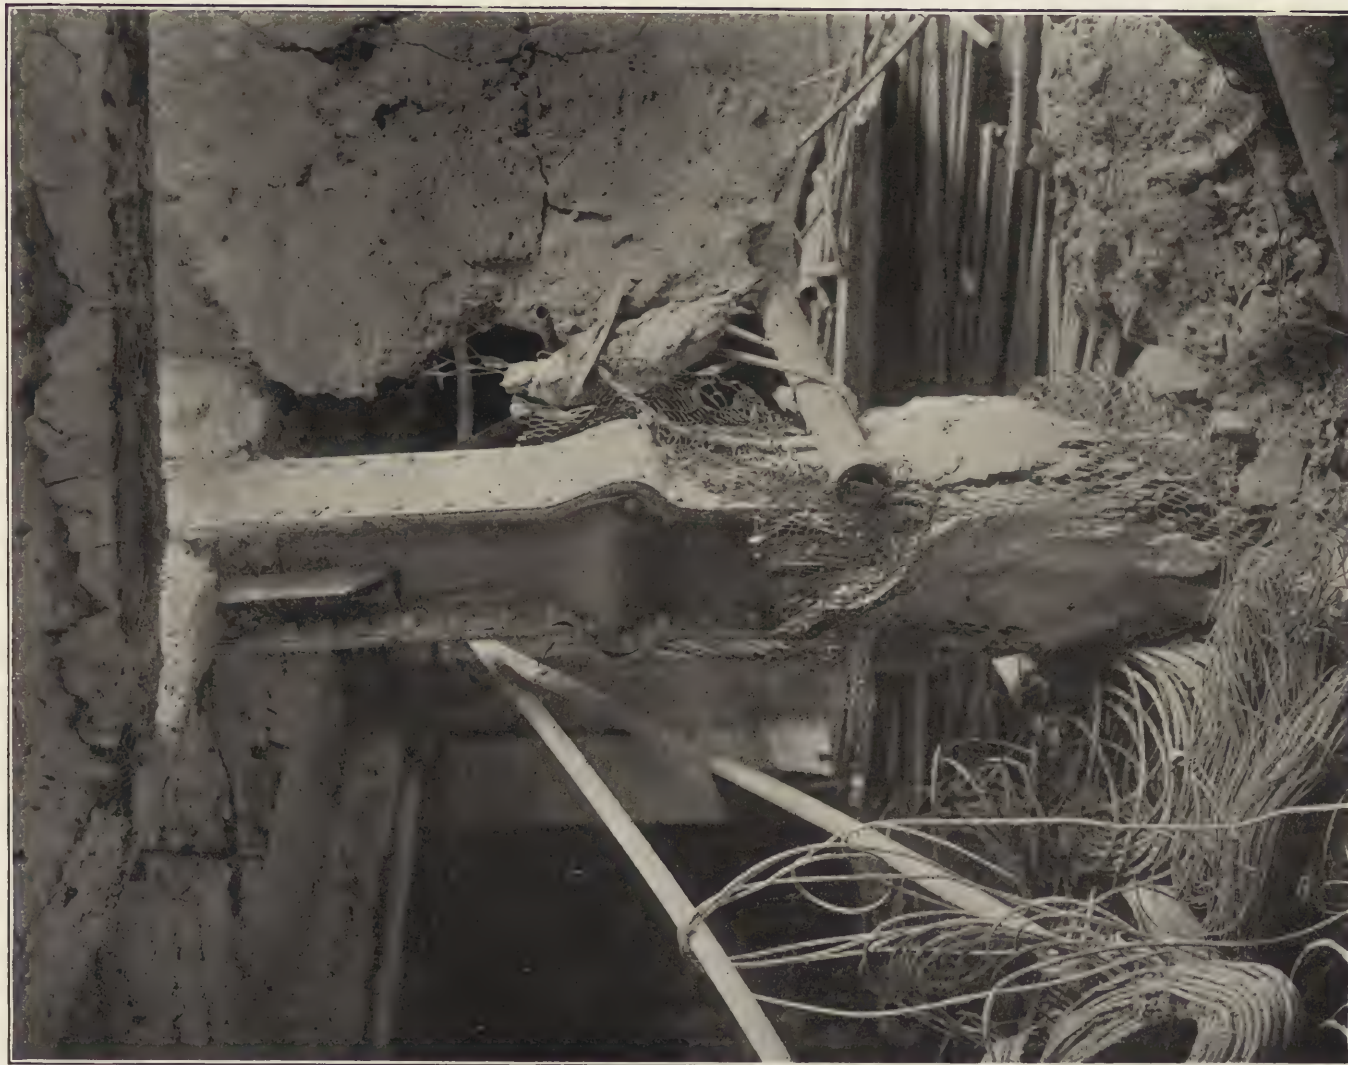
RIALTO BUILDING. Basement Story. Showing a buckled column under the wrecked portion on the New Montgomery Street side. Falling *débris*, sufficiently heavy to break down a section of the flooring, only cracked the soffit protection, which is still adhering to the beams.

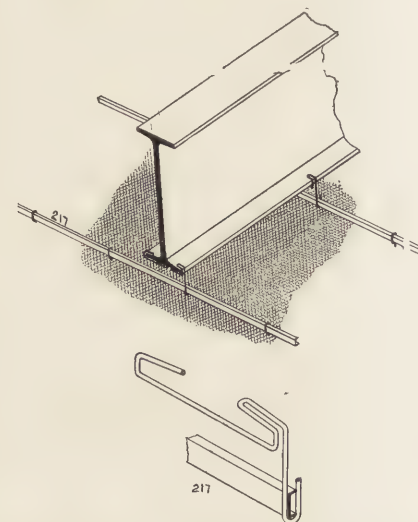
The light section of the wire clip was quickly heated when exposed to fire, and thus weakened, it straightened out, permitting the entire ceiling construction to fall away from the beams in many places. Ceiling clips of such light sections are undesirable, and should not be used where an efficient and fire-resisting ceiling construction is required.

Wire Ceiling Clip that Failed in Moderate Fires.

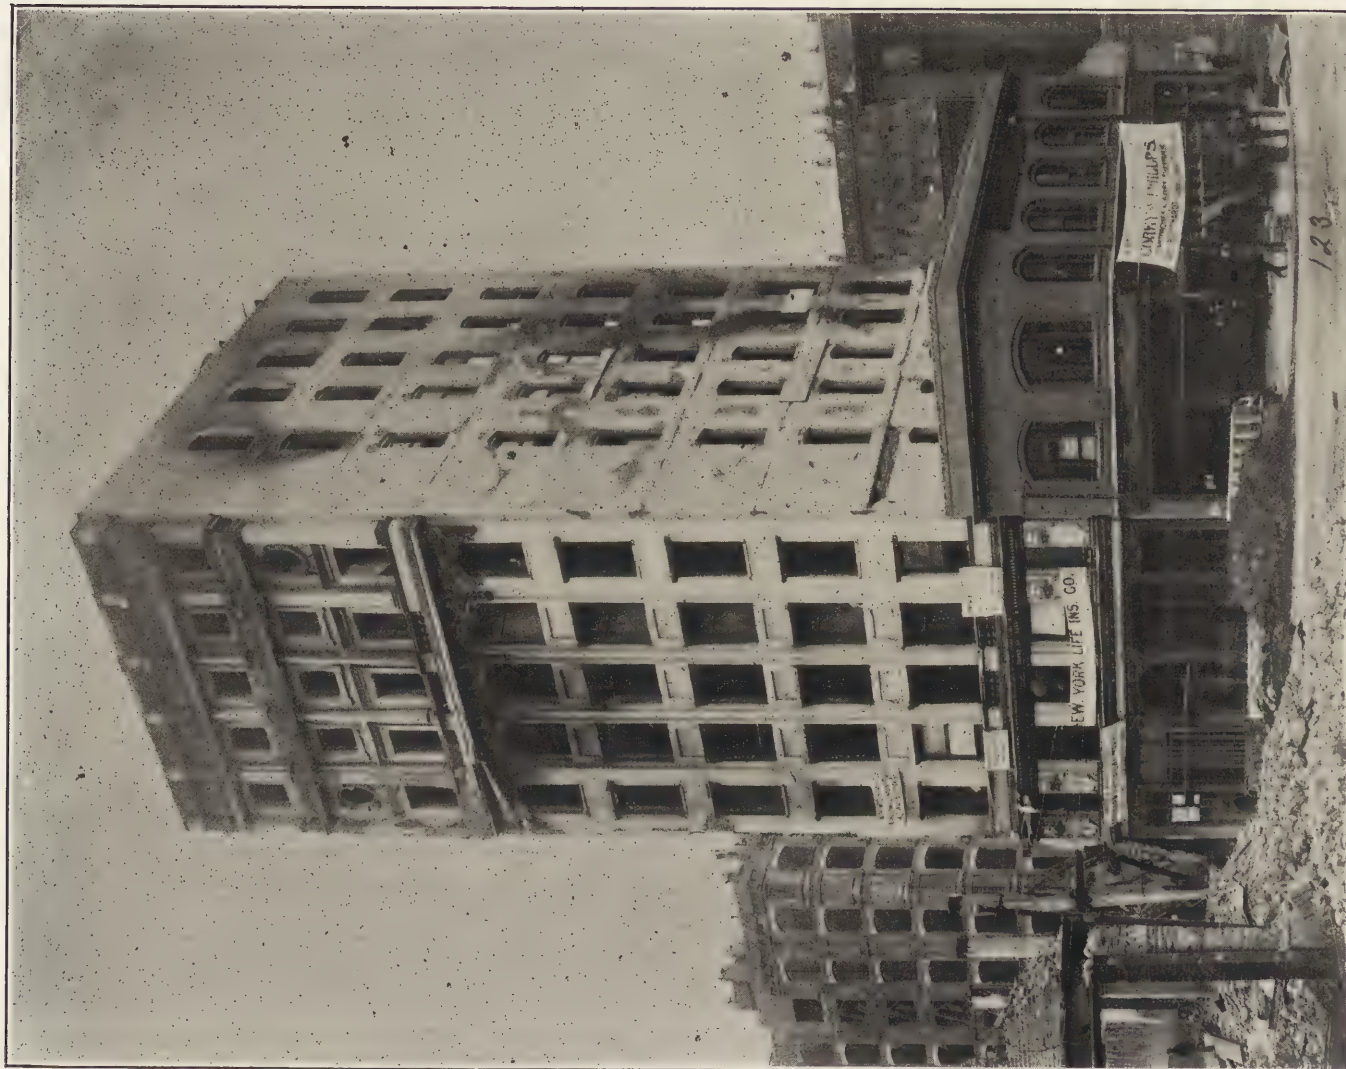
ATLAS BUILDING. 604 Mission Street. The walls are of common brick with cementine finish. The "X" cracks between the windows and the spalling of the corners of the walls are characteristic features of the earthquake. On account of the inexpensive exterior finish of this building, the repairs will probably cost much less than in cases where the façades are of stone or terra cotta. The fire entered from the rear, consuming the interior of the upper stories only, and causing comparatively little damage below. The floors are of concrete, and the partitions of metal lath and plaster. The low two-story building at the right escaped the fire, and is but little damaged.
